NTSB National Transportation Safety Board

Cessna Citation 560
operated by Martinair, Inc.
Pueblo, CO

February 16, 2005

Cessna Citation 560

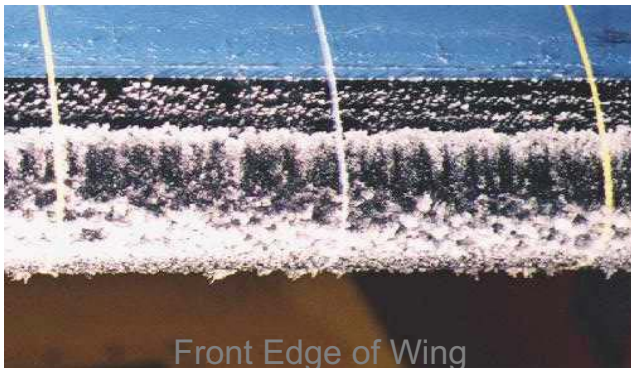
SLD Ice

- Failure to Monitor Airspeed
- Failure to Activate Boots
- Inadequate Icing Certification Standards

- Improved training for C-560 pilots to emphasize flight manual requirements for flight in icing conditions.
- Train monitoring and cross-checking
- Revise flight manual guidance regarding de-ice boot activation.
- Require modifications to C560 stall warning system.
